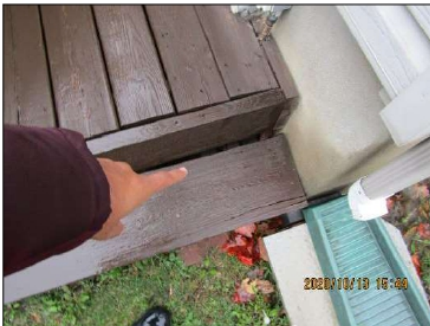
- The inspector observed uneven/loose steps on the rear deck during our inspection. It is considered a safety hazard, and it should be corrected to enhance safety.
- General information: Treated woods requires annual treatment. This includes cleaning with specialized products and water pressure following by treatment application to preserve the remaining life expectancy and rot. It is recommended to consult with a specialized contractor for proper applications along with all associated costs.
- Loose and insecure guard rails were noted on the rear deck. The inspector also observed a missing door during the inspection. This is considered a safety hazard, and it should be corrected to enhance safety.

Uneven step noted

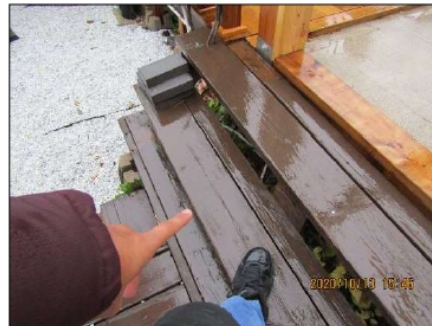
Uneven/loose step

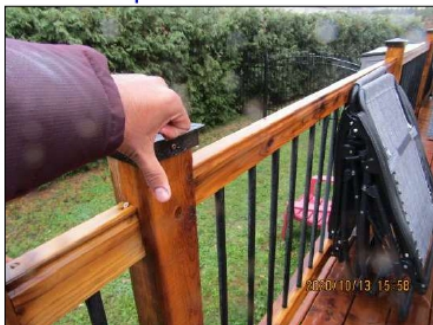
Loose guardrail

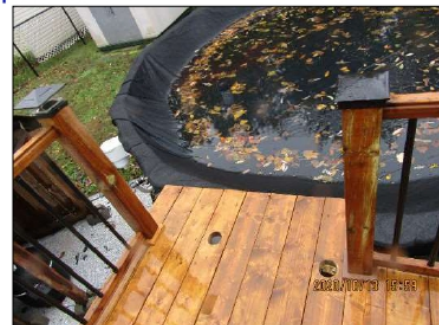
Missing door

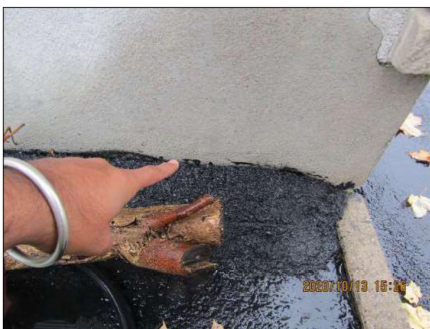
Gap needs to be filled

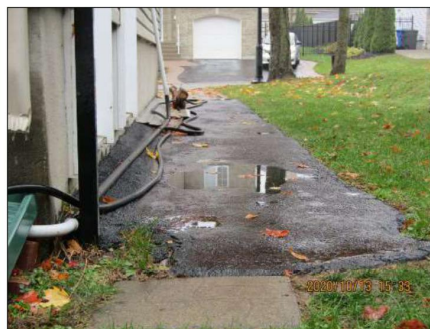
- A negative slope observed all around the foundation. It is strongly recommended to have a positive slope all around the foundation in order to drive the water away from the building and to prevent seepage and water infiltration into the basement.

Negative slope (towards the foundation)

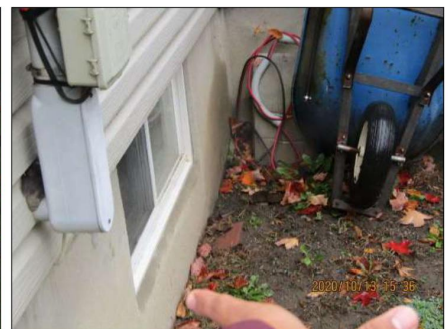
Overflowing gutters and negative slope

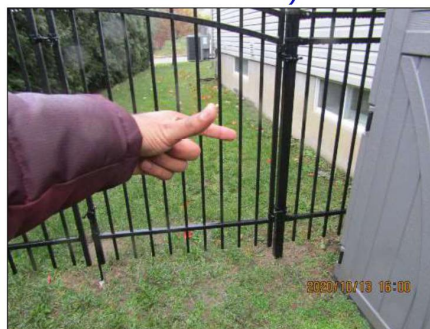
Negative slope (right side of the house)

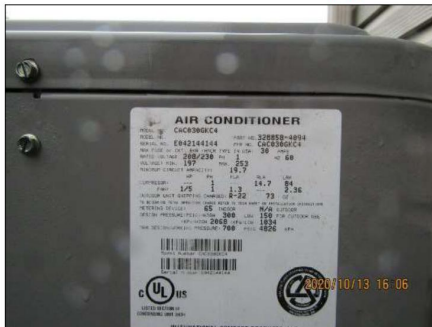
- Air conditioning systems did not operate due to outside temperature. Activating air conditioning during cool/cold weather (Generally less than 18 C) can cause severe damage to the system and the exterior compressor. The buyer is advised to verify with the seller the satisfactory operation prior to purchase (Inspection limitation).
- The dryer vent is venting very close to the condensing unit. Lint can clog the fins and heat can reduce the efficiency of the unit. Improvements required.
- The exterior compressor appears to be manufactured in 2004 (as per data plate) and may not have proper efficiency. The average life expectancy of these units is estimated from 10 to 15 years. Any system that is 15 years or older should be regularly maintained. Budgeting for a replacement is recommended. However, you can keep using it until it is working efficiently.

16 years old

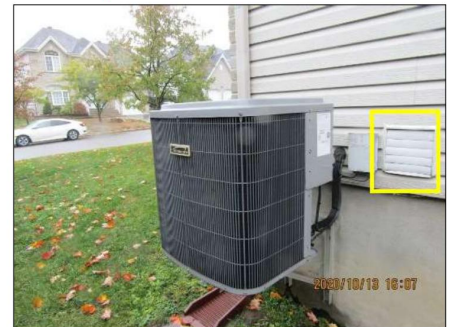
Dryer exhaust vent very close to the AC condenser unit
