PROPERTY INSPECTION REPORT

Montreal

Date of Inspection: 13/10/2020

Year Built: 2005

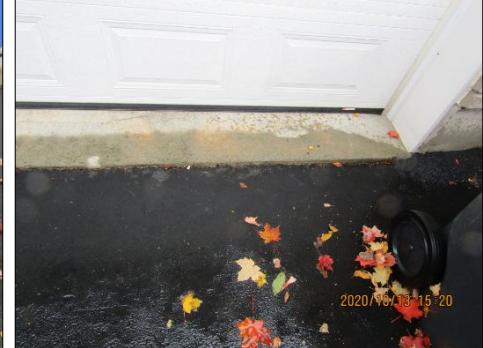
Some settlement (water ponding)

Sloping towards foundation

- It is recommended to treat the asphalt every 3-5 years for proper sealing and as part of regular maintenance.

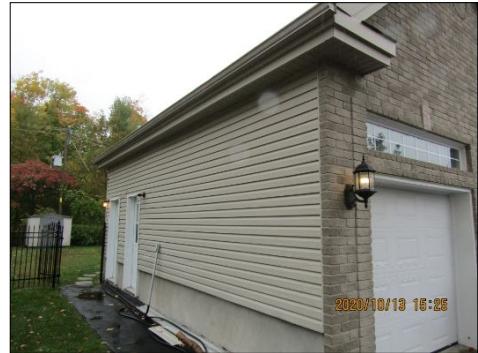
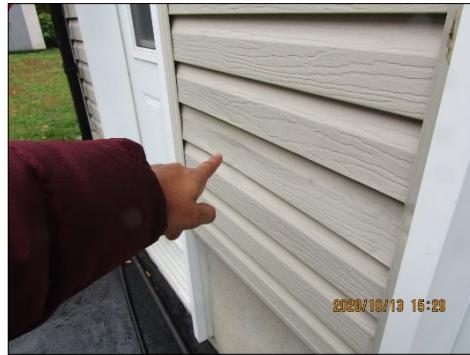
Damaged siding (left side)

Caulk the joints between both bricks

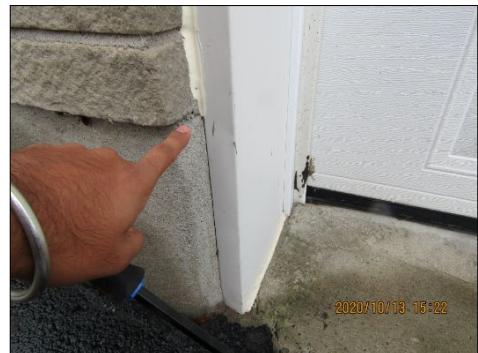
Missing caulking (near the bottom of garage door)

<i>Exterior</i>		
Page 13 Item: 4	Exterior caulking condition	<ul style="list-style-type: none"> Important caulking needed, there are areas which need immediate repairs, a caulking specialist should be contacted.
Page 17 Item: 9	Grade/Slope and Drainage Conditions	<ul style="list-style-type: none"> A negative slope observed all around the foundation. It is strongly recommended to have a positive slope all around the foundation in order to drive the water away from the building and to prevent seepage and water infiltration into the basement.
Page 18 Item: 10	Deck Condition	<ul style="list-style-type: none"> Loose and insecure guard rails were noted on the rear deck. The inspector also observed a missing door during the inspection. This is considered a safety hazard, and it should be corrected to enhance safety.
Page 19 Item: 12	Exterior Comments	<ul style="list-style-type: none"> Damaged/old caulking around doors, windows, penetrations etc. needs to be repaired to prevent water infiltration and further damages.

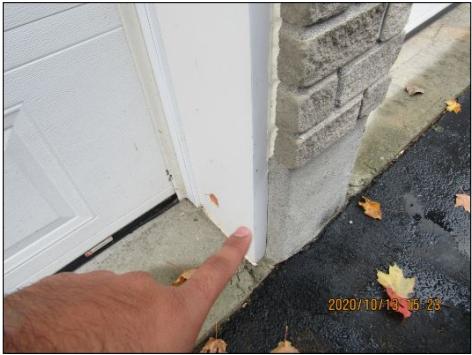
Missing caulking (near the bottom of garage door)

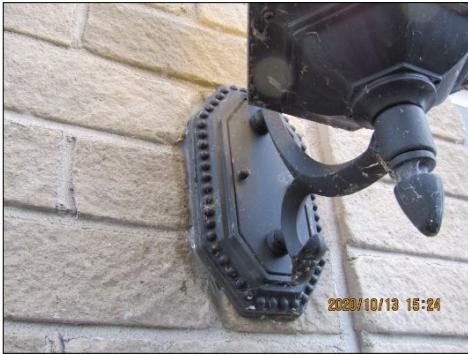
Damaged Caulking (siding on left side)

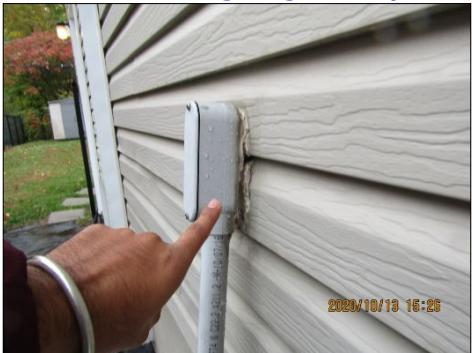
Damaged caulking

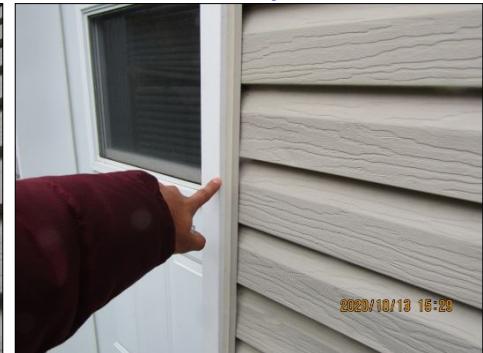
New caulking needed

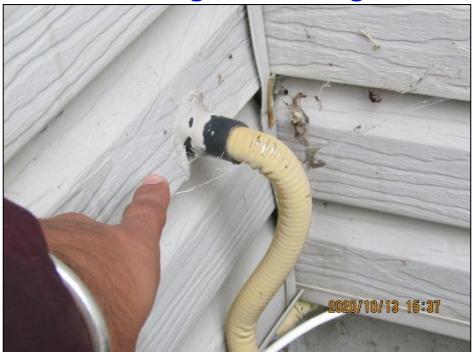
Damaged caulking

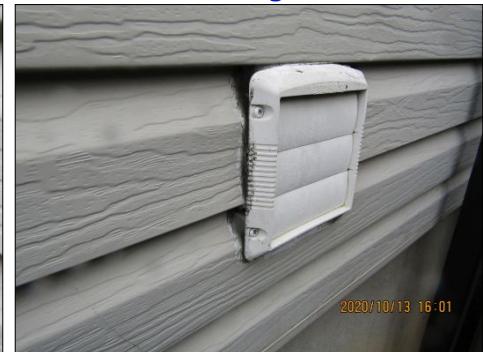
Damaged caulking

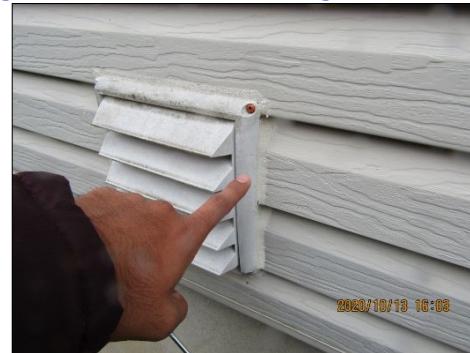
New caulking needed

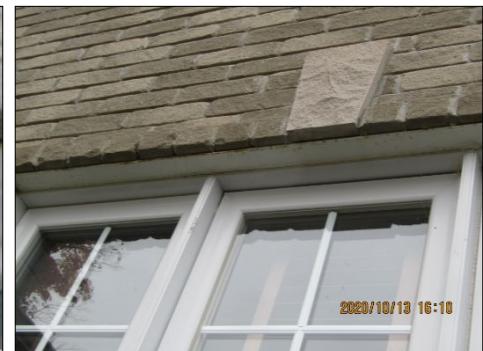
Garage window lintel needs rust protection

Lintel needs to be painted

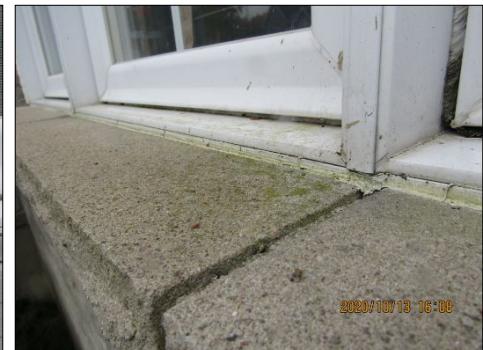
- Poor condition of caulking observed in various areas around doors and windows. These condition may lead to water infiltration causing damages to the interior components. Repairs and corrections recommended.
(This is part of regular maintenance. The general life expectancy of exterior caulking is between 3 to 7 years).

Damaged caulking

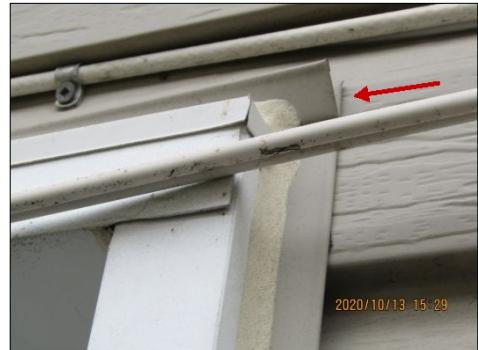
Defective flashing above exterior basement door

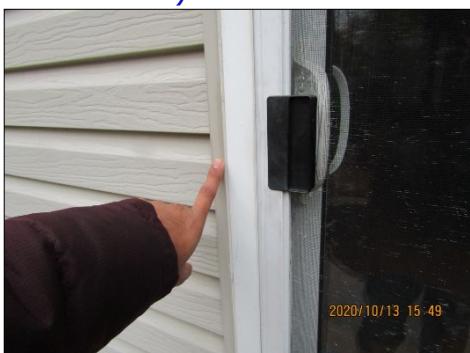
Damaged caulking around patio door

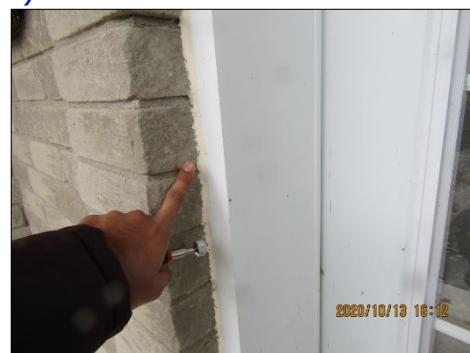
New caulking needed

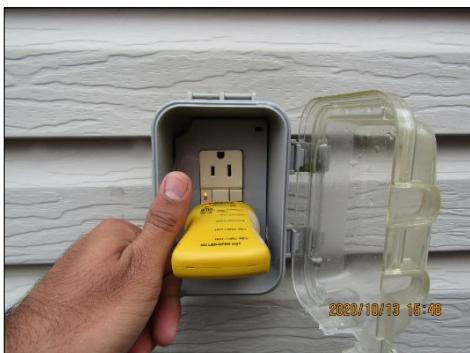
- The exterior outlet near the deck was not grounded at the time of the inspection; therefore, it was not protected with **GFCI**. Corrections are recommended as per today's standards to enhance safety. Consult with a certified electrician.

GFCI OK

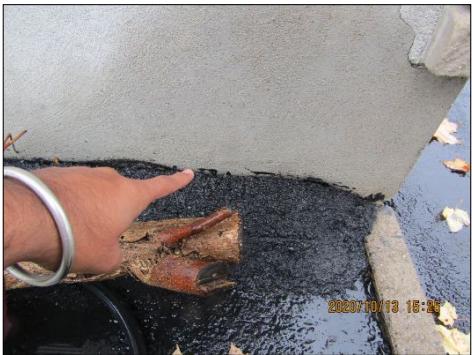
- A negative slope observed all around the foundation. It is strongly recommended to have a positive slope all around the foundation in order to drive the water away from the building and to prevent seepage and water infiltration into the basement.

Gap needs to be filled

Negative slope (towards the foundation)

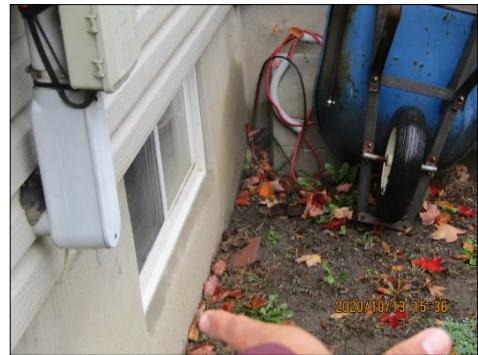
Overflowing gutters and negative slope

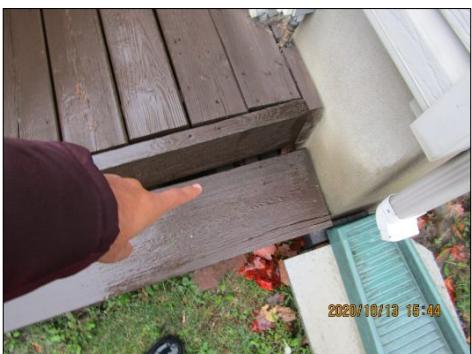
- The inspector observed uneven/loose steps on the rear deck during our inspection. It is considered a safety hazard, and it should be corrected to enhance safety.
- General information: Treated woods requires annual treatment. This includes cleaning with specialized products and water pressure following by treatment application to preserve the remaining life expectancy and rot. It is recommended to consult with a specialized contractor for proper applications along with all associated costs.
- Loose and insecure guard rails were noted on the rear deck. The inspector also observed a missing door during the inspection. This is considered a safety hazard, and it should be corrected to enhance safety.

Uneven step noted

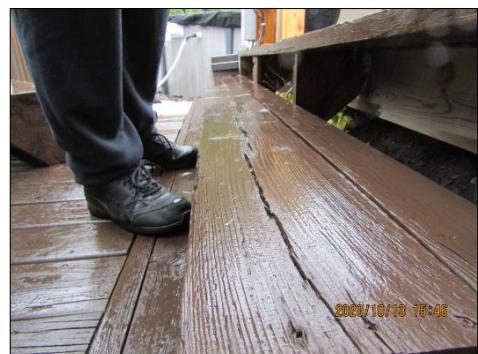
Loose guardrail

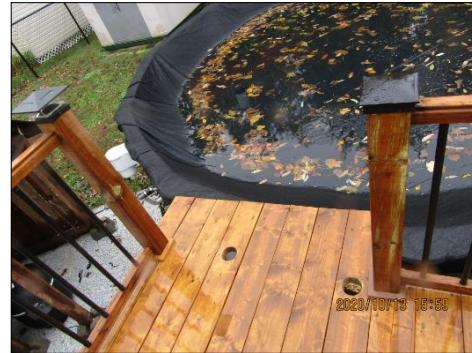
Missing door

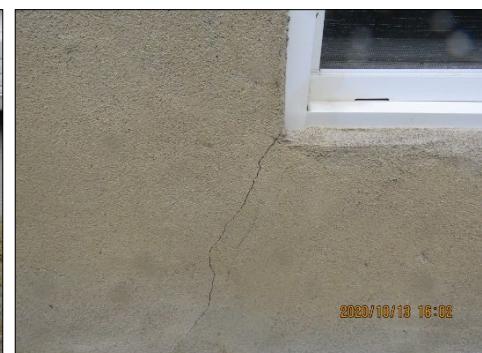
Minor crack (right side below window)

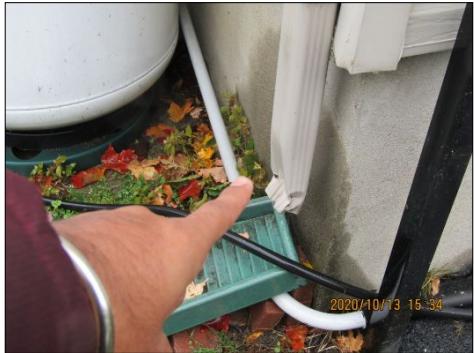
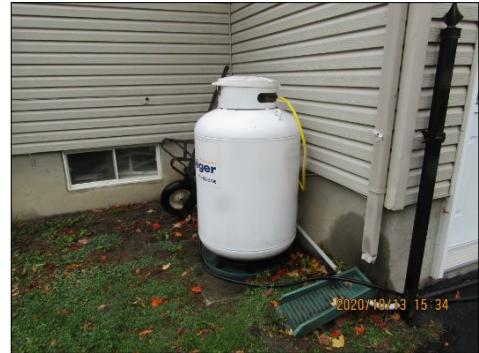
For proper downspout drainage, gutters should always discharge away from the foundation. Water can infiltrate in the basement if left along the side of the foundation.

Downspout needs an extension

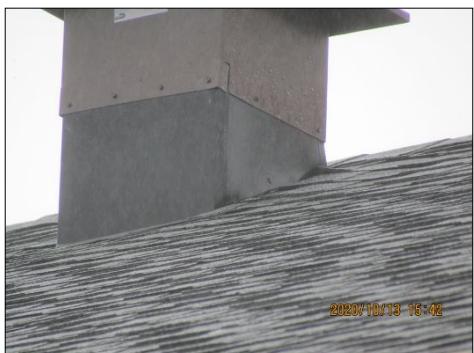
Minor damage on maximum vent

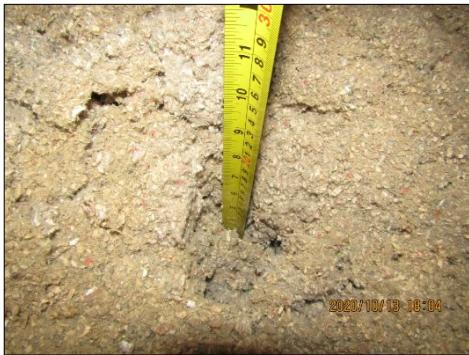
7-8 inches of insulation

- Recommend adding additional 3-4 inches of insulation to improve the energy efficiency of the house.

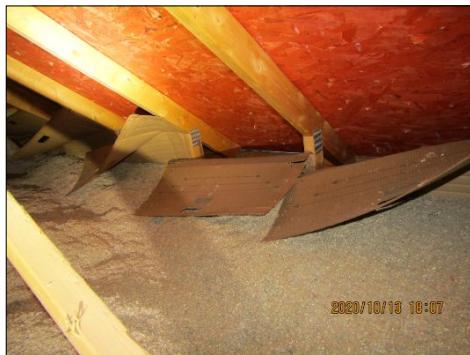
misplaced waferboards

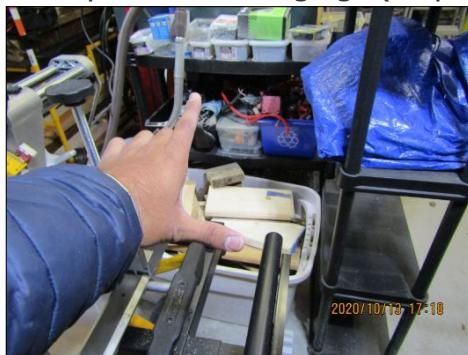
Could not be able to inspect the drain due to the storage (Limitation)

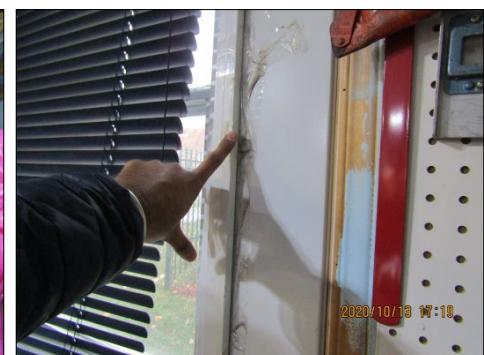
Tape and loose frame noted

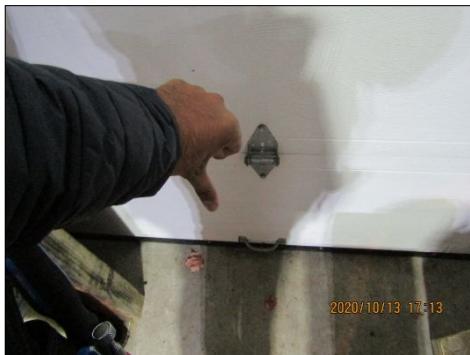
- Automatic, left door was tested for regular functionality. Right door was not able to operate due to storage.
- Door opener is wired with an extension cord. Ideally, garage door openers should be powered by a dedicated receptacle. Client should consider installation of a dedicated receptacle as a safety upgrade. All repairs/upgrades should be performed by a licensed electrician to ensure safety.
- Adjust reverse tension, the force to execute a return is greater than 15 pounds, see owner's manual for the opener, to find out where the adjustment can be done.

Return mechanism not properly working

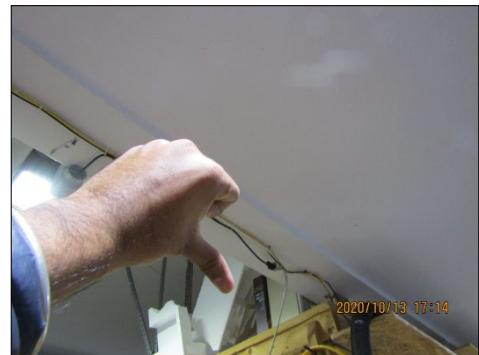
Extension cord

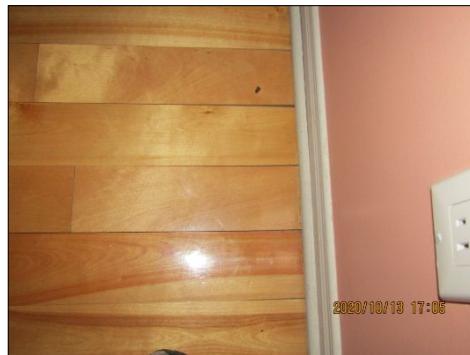
- Usable with normal wear and tear considering the age of the building.
- Minor openings and gaps observed in living area beneath the previous water damage (declared in D.V.)

Previous water leak (declared in D.V.)

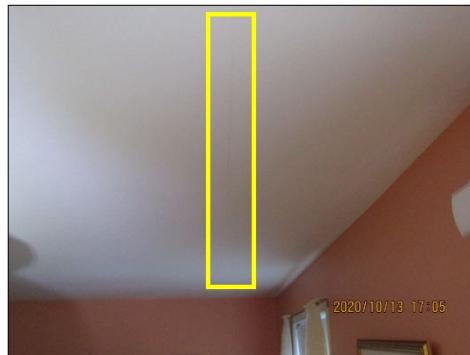
- Evidence of previous water infiltration was noted on the ceiling (Declared in D.V.). Although, it is dry at the time of the inspection, we recommend monitoring the situation and improve if any leakage noted.

Previous water leak (declared in D.V.)

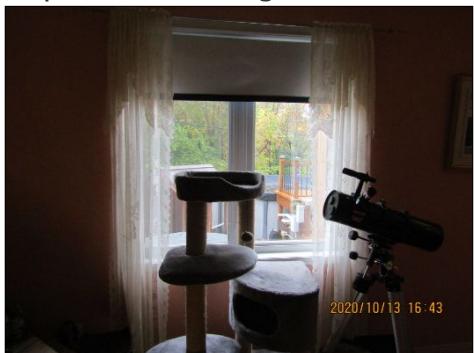
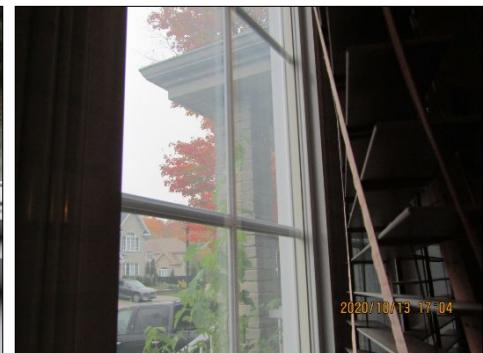
- (Broken Seal) Overall acceptable considering the age of the building, however the windows (thermal pane seals) are towards the end of their life expectancy, and they will require to be replaced in near future. Failed seals reduce the energy efficiency of the windows. It is recommended to consult with a qualified contractor for further evaluation of proper replacement along with all associated costs.

Broken seal (throughout the house)

Another example of the broken seal

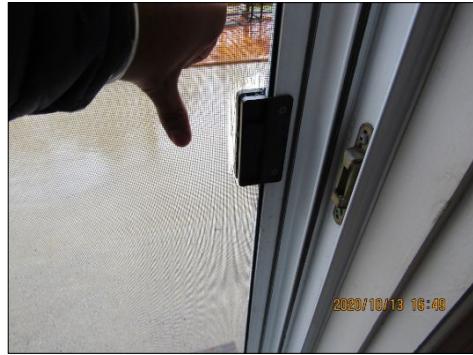
- We observed the rear door screen was damaged. Improve as required.

Damaged screen

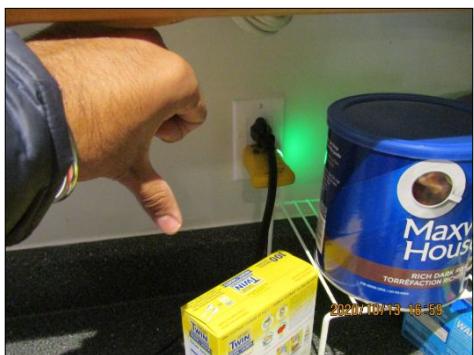
<i>Kitchen</i>		
Page 37 Item: 4	Kitchen Electrical Conditions	<ul style="list-style-type: none"> No GFCI protection present, suggest installing GFCI protected receptacles for safety. Presence of a live wiring noted at the bottom of the kitchen cabinet. This is considered a safety hazard. Immediate action should be taken to improve the situation.

- GFCI protected receptacles may not have been required when the house was built. We suggest buyer consider upgrading with GFCI's at all receptacles near water sources.
- No GFCI protection present, suggest installing GFCI protected receptacles for safety.
- Presence of a live wiring noted at the bottom of the kitchen cabinet. This is considered a safety hazard. Immediate action should be taken to improve the situation.

Missing GFCI

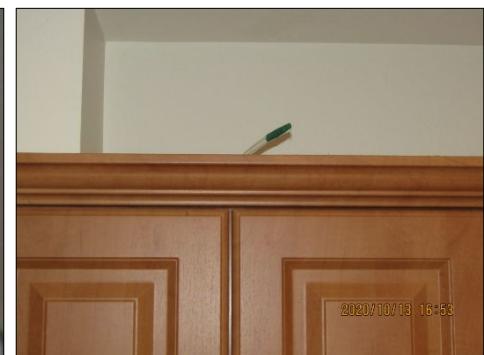
Live wires noted

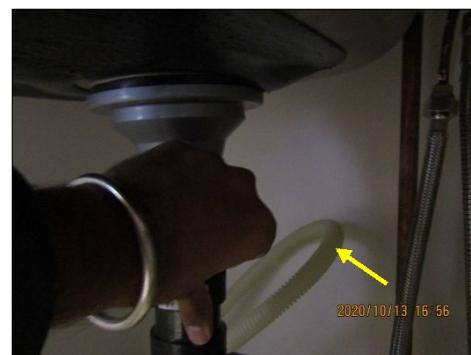
- It is recommended to attach the dishwasher drain to the bottom of the counter top (from inside) to prevent back water flow into the dishwasher and contamination in case of blockage of the sink drainage pipes.

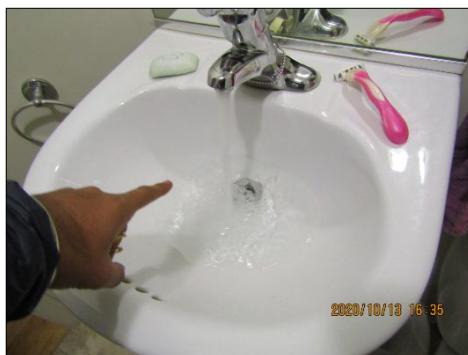
- We observed the sink was draining slowly at the time of the inspection. Cleaning/improvements required.

Slow drainage

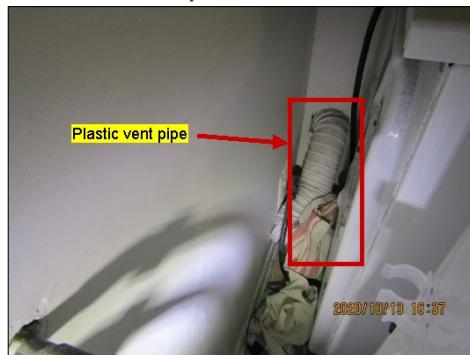
- The dryer vent is made of plastic. These materials may lead to moisture build up and improper ventilation. Upgrading to aluminum type is recommended.
- Modern dryers use higher drying temperatures; this is the reason behind the recommended use of metal piping. Plastic is no longer a suitable product for hot air exhaust.

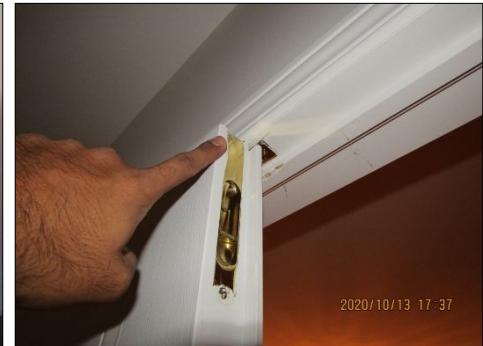
- The inspector observed that the door in the first bedroom did not close properly due to the carpet.
- The Master bedroom door did not latch properly, needs adjustment.
- Overall Usable

Did not properly close

Did not close properly

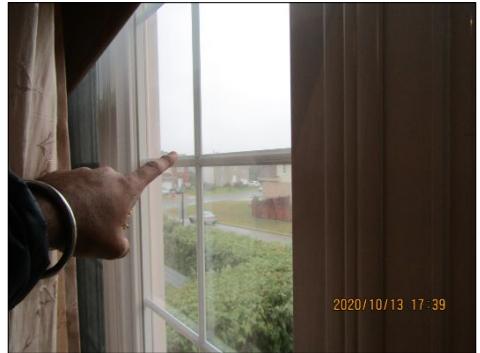
2020/10/13 17:39

One example of broken seal (all bedroom windows have the same issue)

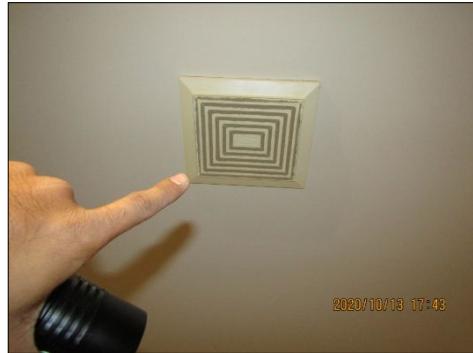
- Poor suction noted. This condition may lead to high level of humidity in the bathroom and may lead to mold in concealed areas. Repair/Replacement recommended for proper ventilation.

Clogged, inadequate suction

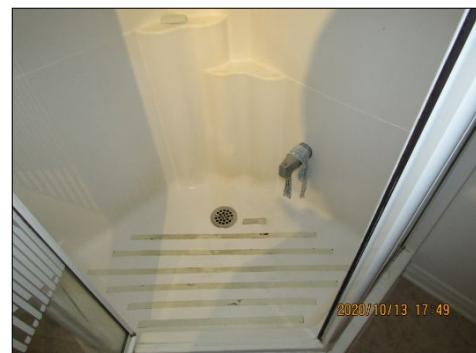
Near the end of its life

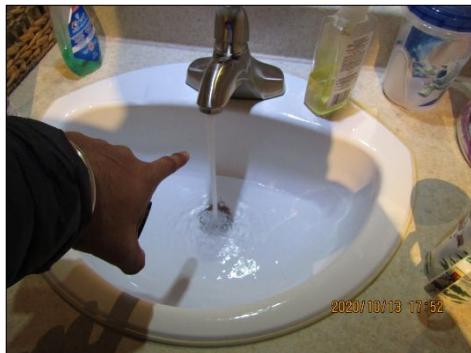
- Low water flow observed. The inspector encountered low water flow on many faucets. Consult with certified plumber to further evaluate and fix the issue.

Poor water pressure

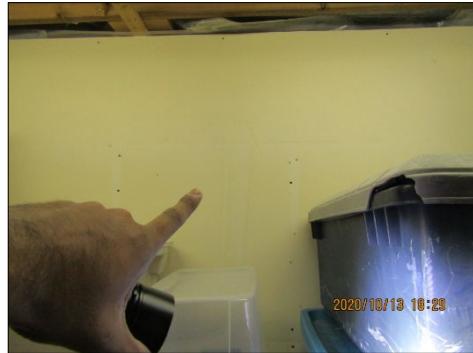
- Previous leak observed. However, dry at the time of the inspection. We recommend monitoring and repair/improve as required.

Previous water leak was observed

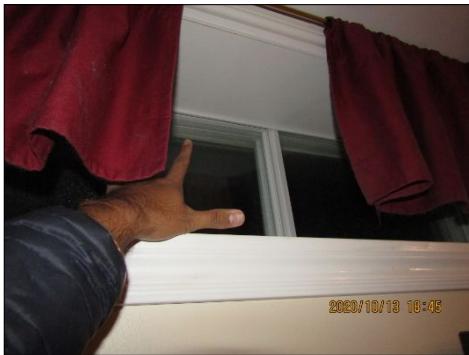
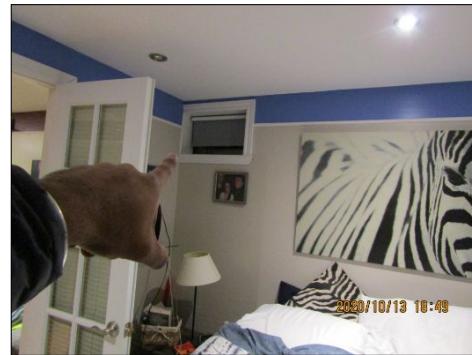
Page 51 Item: 8	Windows Condition	<ul style="list-style-type: none">The window is so small that it can not consider as an egress. The basement should not be used as a bedroom until you increase the size of the window opening. Recommend further evaluation by a specialist.
-----------------	-------------------	---

- Could not able to operate (limitation). Frames may have been compressed during installation, and/or damage has occurred. Further evaluation is needed by a specialist.
- It is recommended to open the windows for about one minute a day, or on regular basis to help proper ventilation of the basement.
- The window is so small that it can not consider as an egress. The basement should not be used as a bedroom until you increase the size of the window opening. Recommend further evaluation by a specialist.

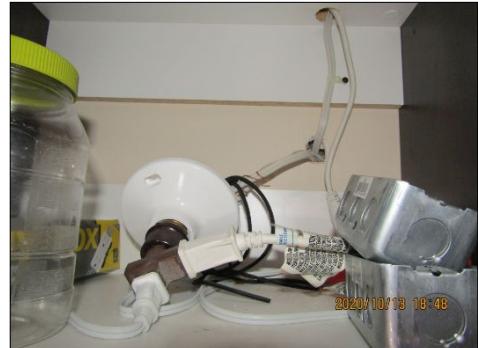
Page 54 Item: 1	Kitchen Electrical Conditions	<ul style="list-style-type: none">No GFCI protection present; suggest installing GFCI protected receptacles for safety.Presence of a loose outlet noted above the kitchen sink cabinet. This is considered a safety hazard. Corrections required to enhance safety.
-----------------	-------------------------------	--

No GFCI

Loose electrical connection noted above the sink cabinet

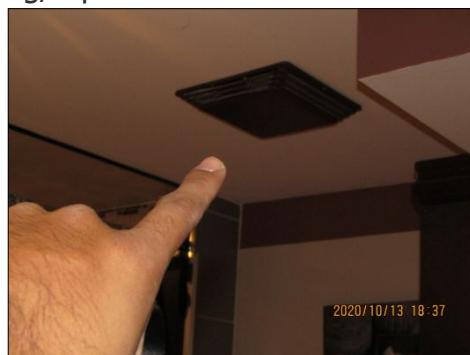
- Exhaust fan was noisy. Upgrading/replacement is recommended.

Noisy fan

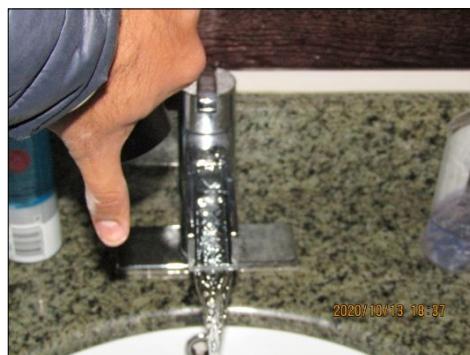
- Low water flow observed.

Low water flow

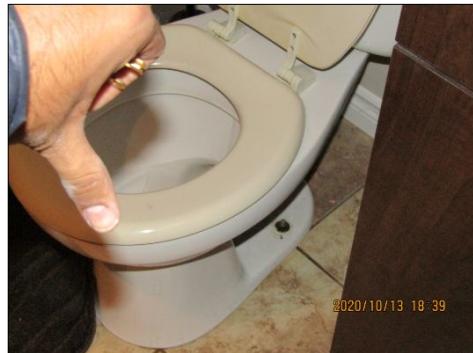
- Loose toilet was noted. This condition could result leakage and damages to the subfloor and other components. Corrections are required.

Loose

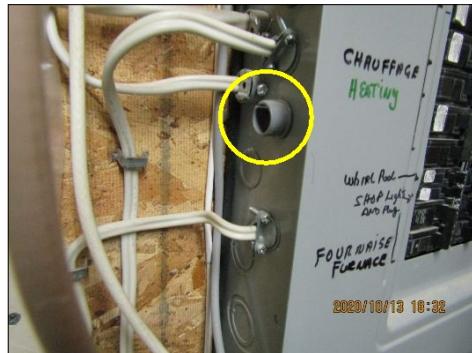
- Opening in the main panel noted. It is recommended to install a plastic cover for security reasons.

Unused opening

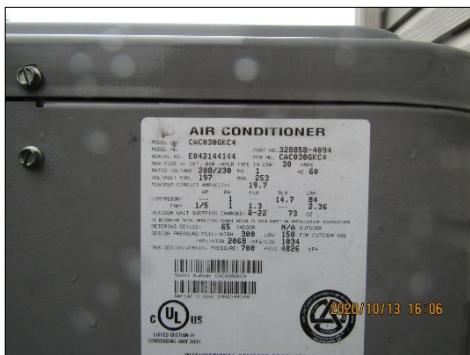
Page 68 Item: 1	Air Conditioning Comments	<ul style="list-style-type: none">The exterior compressor appears to be manufactured in 2004 (as per data plate) and may not have proper efficiency. The average life expectancy of these units is estimated from 10 to 15 years. Any system that is 15 years or older should be regularly maintained. Budgeting for a replacement is recommended. However, you can keep using it until it is working efficiently.
-----------------	---------------------------	--

- Air conditioning systems did not operate due to outside temperature. Activating air conditioning during cool/cold weather (Generally less than 18 C) can cause severe damage to the system and the exterior compressor. The buyer is advised to verify with the seller the satisfactory operation prior to purchase (Inspection limitation).
- The dryer vent is venting very close to the condensing unit. Lint can clog the fins and heat can reduce the efficiency of the unit. Improvements required.
- The exterior compressor appears to be manufactured in 2004 (as per data plate) and may not have proper efficiency. The average life expectancy of these units is estimated from 10 to 15 years. Any system that is 15 years or older should be regularly maintained. Budgeting for a replacement is recommended. However, you can keep using it until it is working efficiently.

16 years old

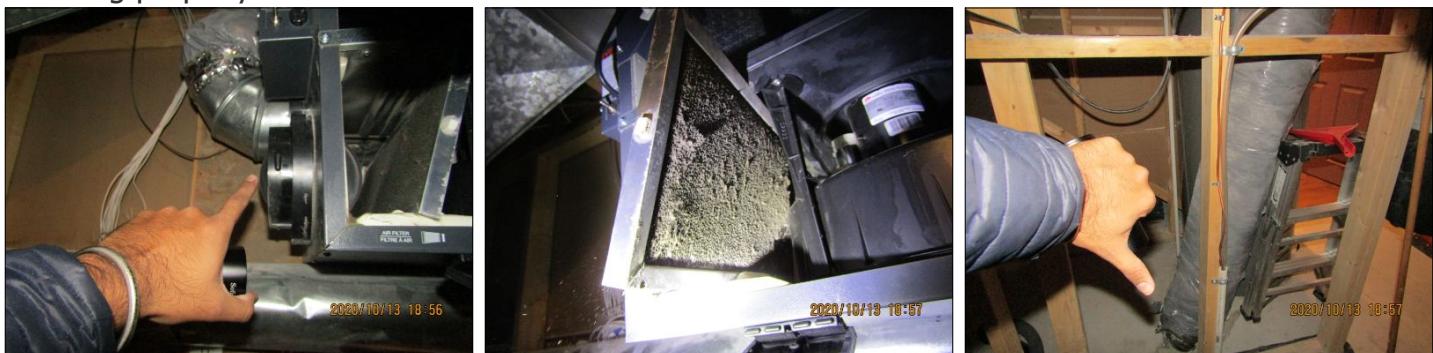
- Dirty filters were noted, it is recommended to change the filters.
- The ducts were not connected at the time of the inspection. Also, the unit was not connected to the power supply at the time of the inspection. The inspector was not able to check if the unit is working properly or not.

- Contact a certified HVAC specialist for estimates of repairs/replacement.
