PROPERTY INSPECTION REPORT

Montreal

Date of Inspection: 13/10/2020

Year Built: 2005

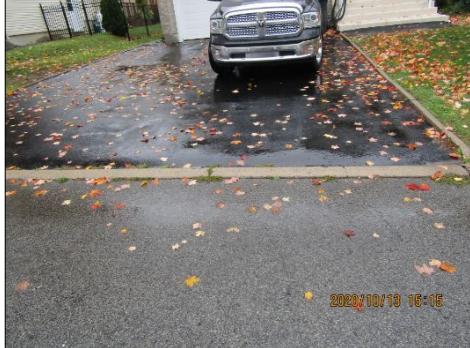
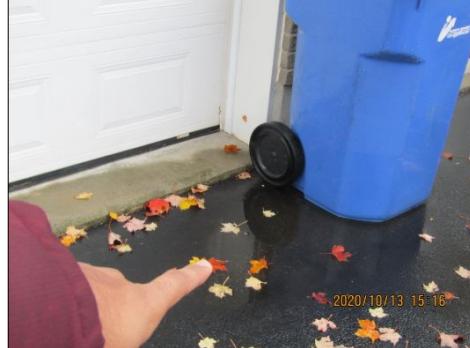
- Evidence of water accumulation was noted due to common settlement in various areas. Repairs and corrections are recommended by a qualified contractor to prevent further damages.

Some settlement (water ponding)

Sloping towards foundation

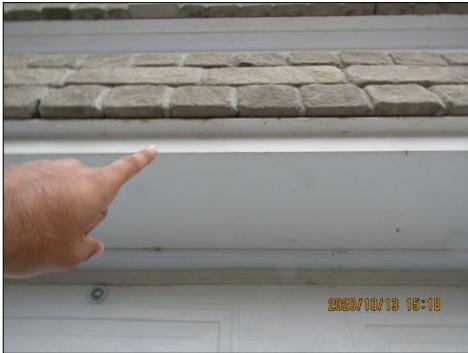
- (Rusted lintels above the garage) Metal lintels above both garage doors require regular maintenance, including sanding, application of anti-rust and exterior paint to prevent rusting as well as patching all cracks and openings to prevent water infiltration.
- Aluminum siding has some mechanical damage on the left side. This damage does not cause any structural issues; however, it does affect the beauty of the overall building.

Rusted lintels above both garage doors

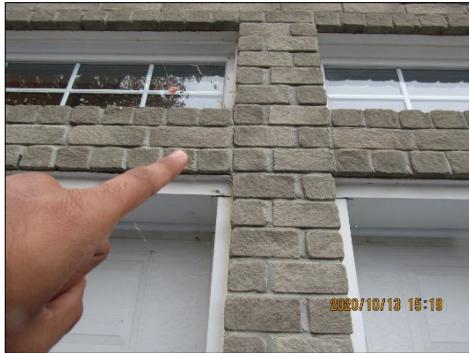
Caulk the joints between both bricks

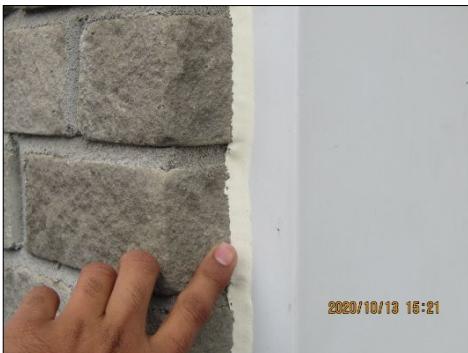
- Important caulking needed, there are areas which need immediate repairs, a caulking specialist should be contacted.**

New caulking needed

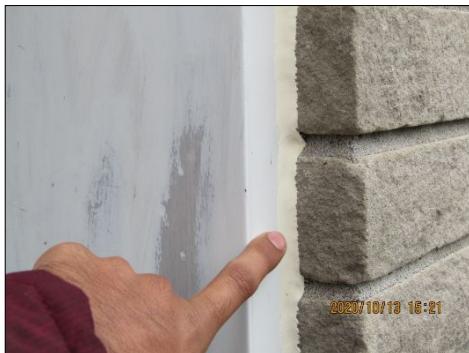
New caulking needed

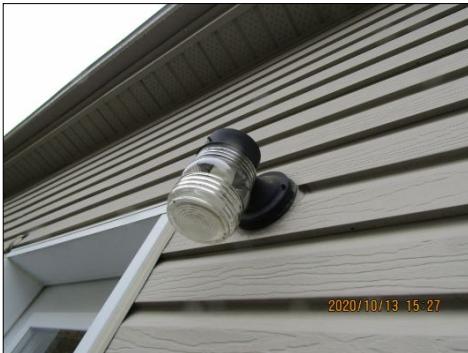
New caulking needed

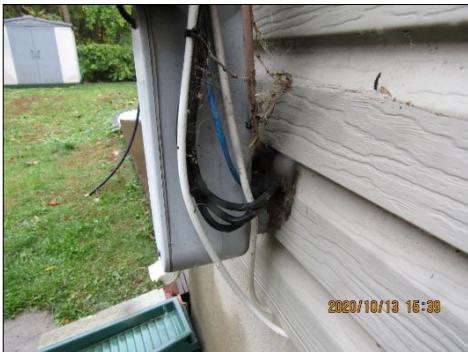
Damaged caulking

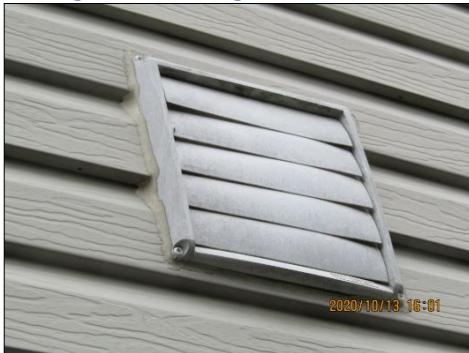
New caulking needed

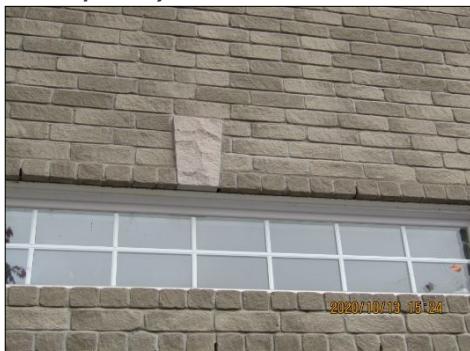
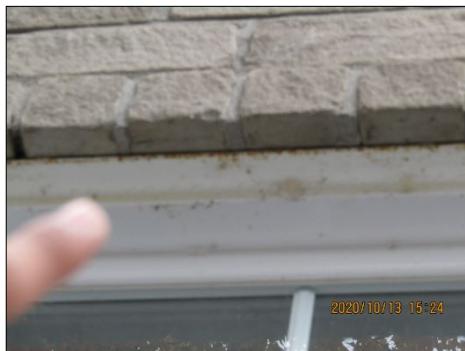
Garage window lintel needs rust protection

Lintel needs to be painted

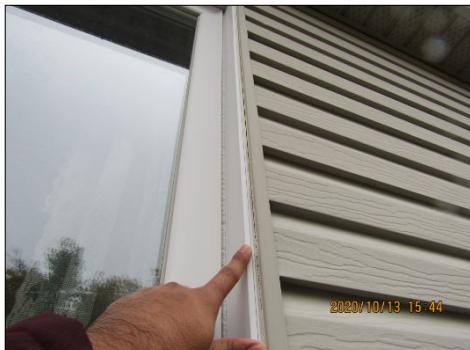
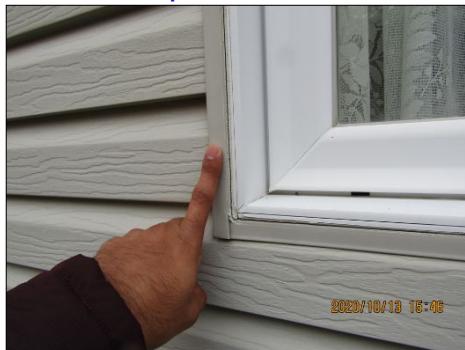
- Poor condition of caulking observed in various areas around doors and windows. These condition may lead to water infiltration causing damages to the interior components. Repairs and corrections recommended.
(This is part of regular maintenance. The general life expectancy of exterior caulking is between 3 to 7 years).

Damaged caulking

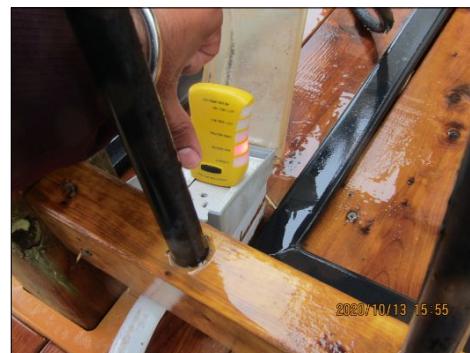
Not grounded

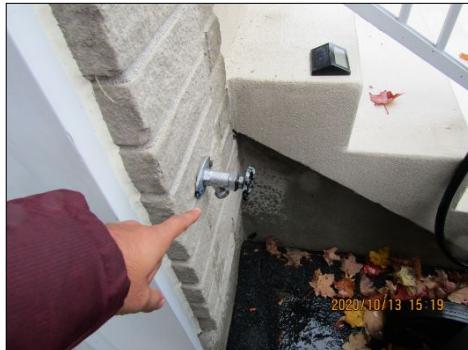
- It is a frost free type. We recommend following the manufacturer's instructions to prevent water freezing during winter.
- The hose bib did not have an anti-siphon device. These devices are designed to stop the flow of potentially contaminated water back into the drinkable water supply. We recommend installing one.

Recommend adding anti-siphoning device to prevent water contamination

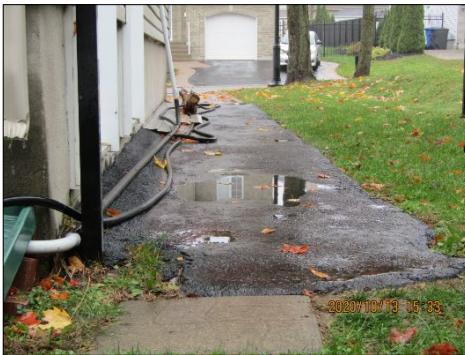
Negative slope (towards the foundation)

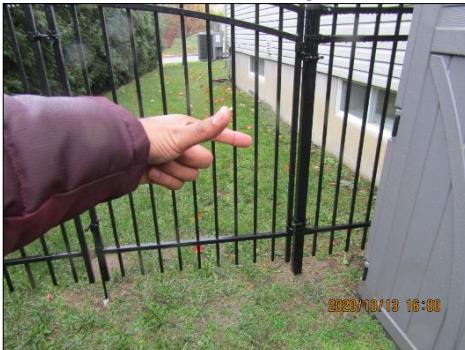
Negative slope (right side of the house)

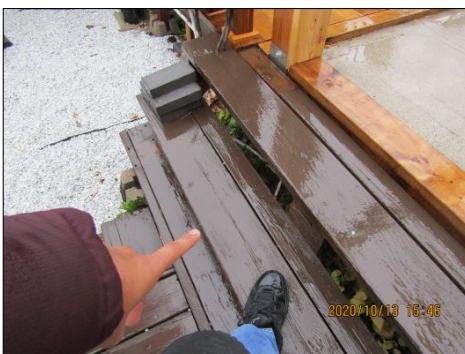
Uneven steps are considered a safety hazard.

Uneven/loose step

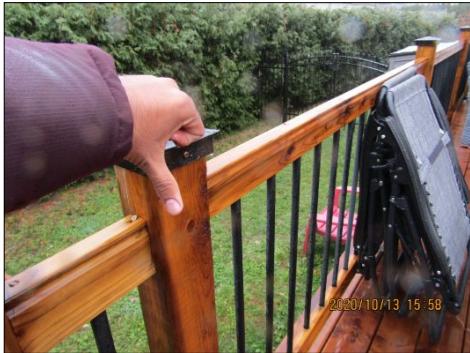
Loose guard rails or handrails are considered a safety hazard, and they should be corrected to enhance safety.

Loose guardrail

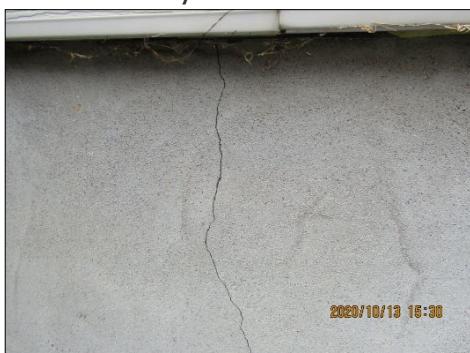
- (Minor cracks) Overall acceptable considering the age of the building; however, the presence of hairline and minor cracks was observed on portions of the foundation. Although these cracks are common and typical, they require close monitoring and are recommended to be treated with "Epoxy" or "Urethane" injection by a qualified contractor to prevent water infiltration. (Please note that all foundations do have cracks; however, they are not always verifiable due to the fact that they are mostly buried under the ground and are not accessible).
- Missing cement parge coat noted on the right portion of the building. Corrections recommended as necessary.

Minor foundation crack (left side)

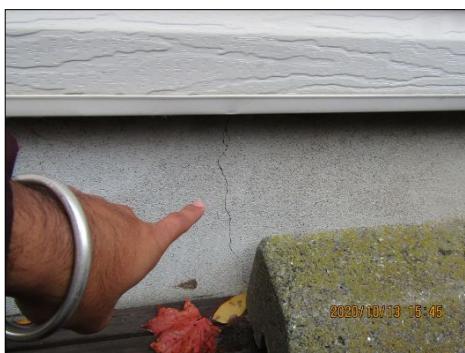
Minor crack

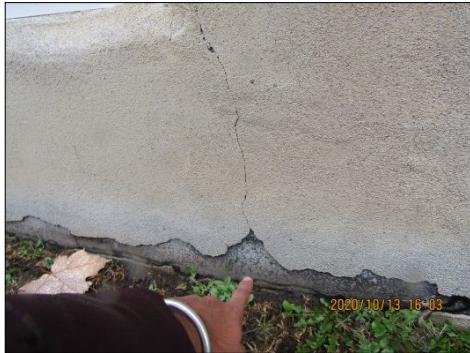
Foundation crack and damaged parging noted

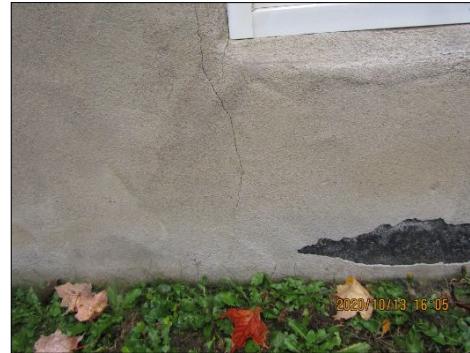
Minor crack (right side)

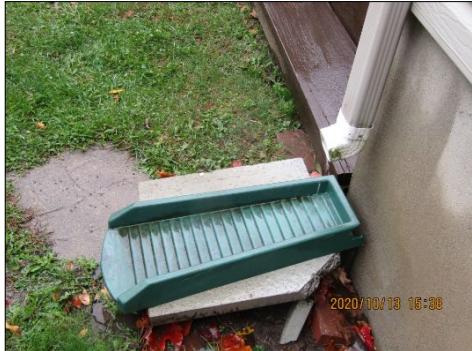
Downspout needs an extension

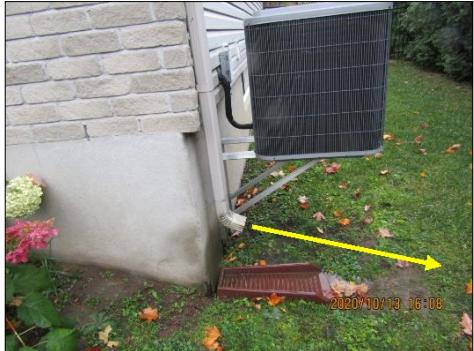
Extension required

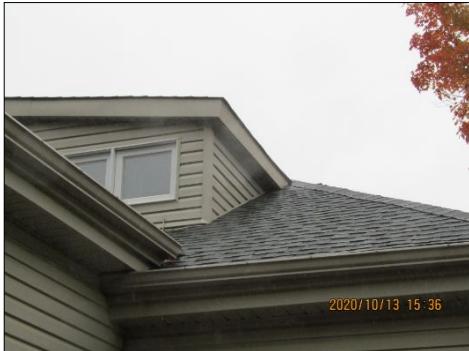
Overflowing gutters

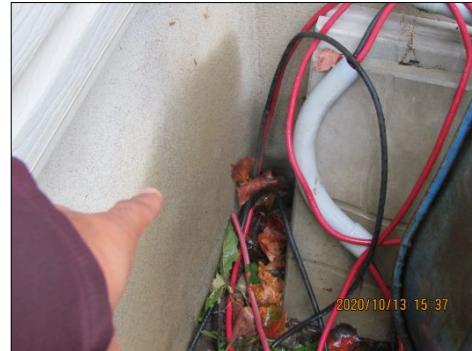
Water from gutter overflow

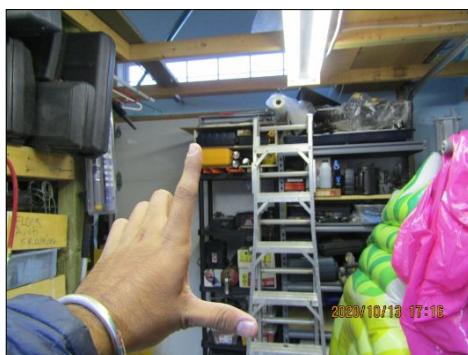
Could not be able to open the second garage door due to the storage (Limitation)

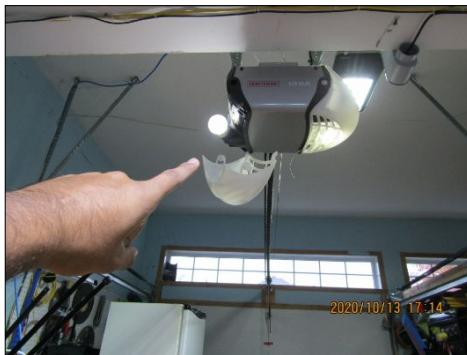
- Automatic, left door was tested for regular functionality. Right door was not able to operate due to storage.
- Door opener is wired with an extension cord. Ideally, garage door openers should be powered by a dedicated receptacle. Client should consider installation of a dedicated receptacle as a safety upgrade. All repairs/upgrades should be performed by a licensed electrician to ensure safety.
- Adjust reverse tension, the force to execute a return is greater than 15 pounds, see owner's manual for the opener, to find out where the adjustment can be done.

Return mechanism not properly working, misplaced light cover

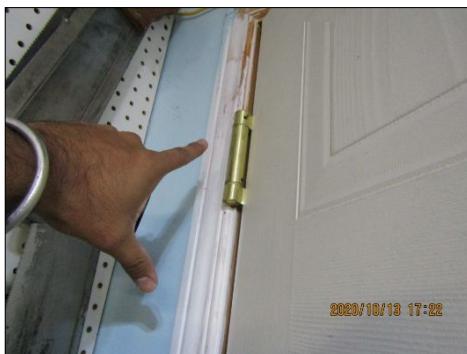
- Self closer requires adjustment for proper closing. (This is to prevent carbon monoxide or smoke entering the building). Corrections recommended.

Not properly closed (garage door to basement)

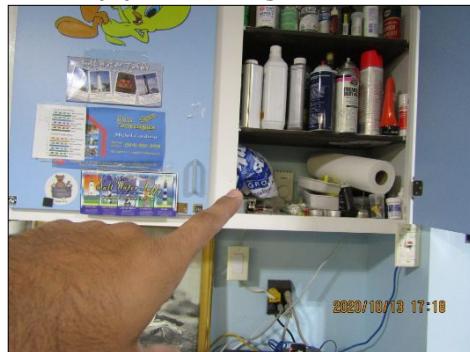
- Functional during the inspection. The thermostat was tested for regular functionality. The thermostat was hidden in the closet, it is recommended to relocate the thermostat.
- It is recommended to keep the heat of the garage at minimum 10 degrees C during winter with electrical baseboard heaters to prevent pipe freezing.

Thermostat is in the closet (not an ideal location)

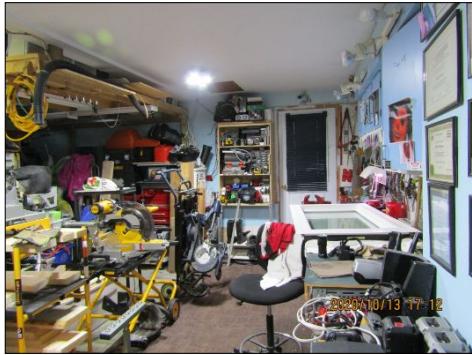
Limitation: Garage storage

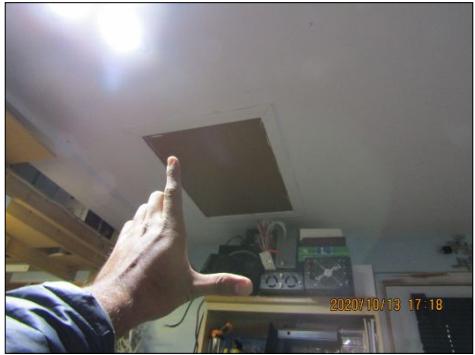
Not allowed to open the access hatch. (Limitation)

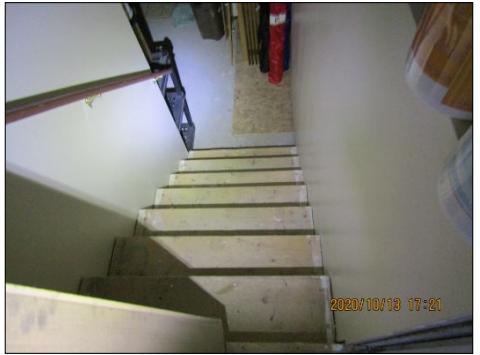
- The garage entrance door is opening over the stairs. This is considered a safety hazard. The door should be opened inward. Immediate corrections are recommended.
- We did not find any CO detector in the hall and basement (access through the garage). To help prevent dangerous situations, we recommend installing CO detectors in all areas of the house closest to the garage. Install them according to current regulations.

Door open over the stairs

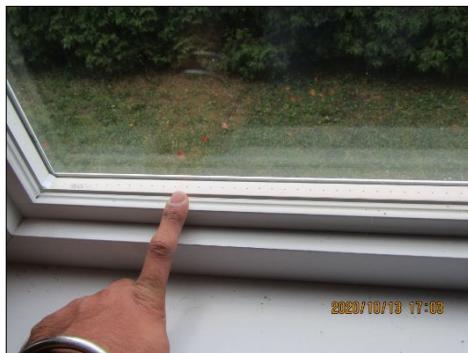
- (Broken Seal) Overall acceptable considering the age of the building, however the windows (thermal pane seals) are towards the end of their life expectancy, and they will require to be replaced in near future. Failed seals reduce the energy efficiency of the windows. It is recommended to consult with a qualified contractor for further evaluation of proper replacement along with all associated costs.

Another example of the broken seal

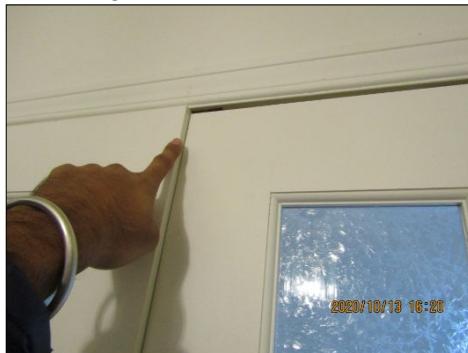
- Door does not close properly, needs adjustment.

Door does not close properly

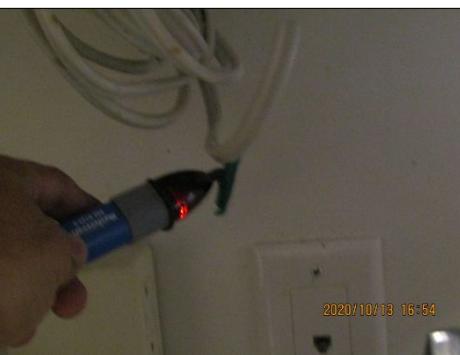
- GFCI protected receptacles may not have been required when the house was built. We suggest buyer consider upgrading with GFCI's at all receptacles near water sources.
- No GFCI protection present, suggest installing GFCI protected receptacles for safety.
- Presence of a live wiring noted at the bottom of the kitchen cabinet. This is considered a safety hazard. Immediate action should be taken to improve the situation.

Live wires noted

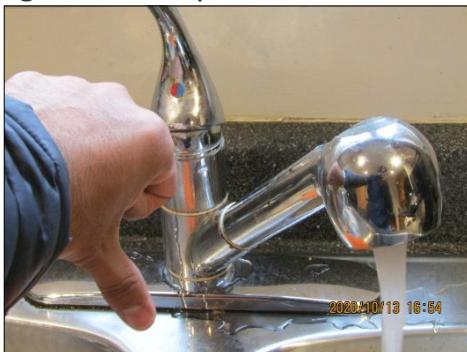
- Faucet leak. Improvements required to prevent the water damage.
- Low water flow observed. This problem was observed on many faucets. We recommend consulting a certified plumber for further evaluation.

Leaky faucet

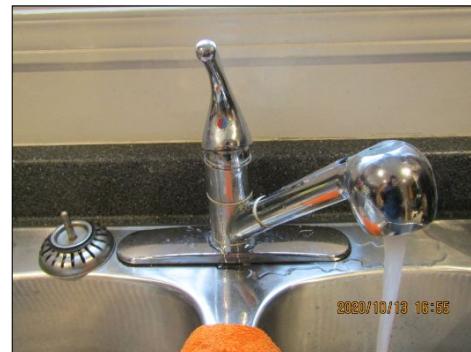
Inadequate flow

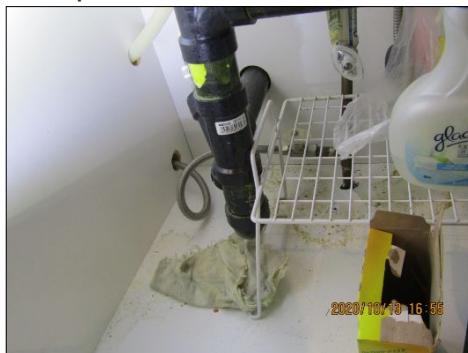
- Water stains noted under the sink, however, dry at the time of the inspection. We recommend to monitor the situation and correct if required.

Previous water damage observed, dry at the time of the inspection

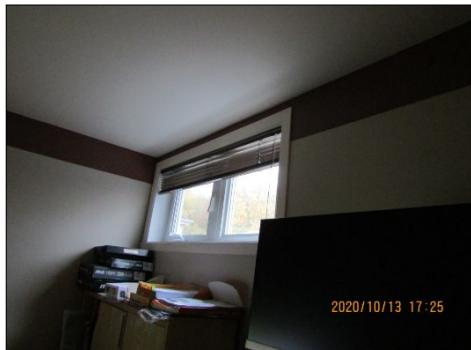
- Could not able to verify the window's condition due to the storage and height. (Inspection Limitation)

Limitation

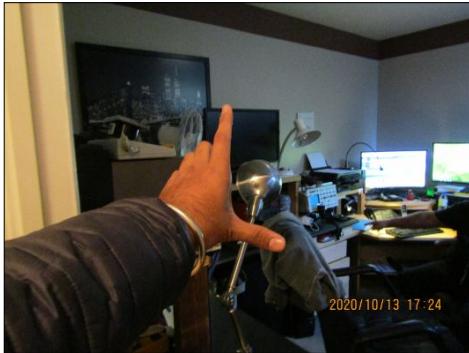
Inspection limitation (Storage)

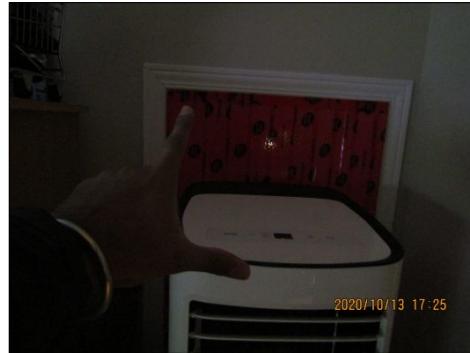
- The inspector was not able to inspect the full room due to storage limitations.
- Access to the attic was not granted by the owner. (Inspection Limitation) However, the inspector observed that the heater was venting into the attic. This condition can add to the humidity level of the attic causing structural wood rot and even mold in concealed areas. It is recommended for all vents to be vented to the exterior. We recommend to further evaluate and verify the situation.

Did not get permission to open the attic access hatch (Inspection Limitation)

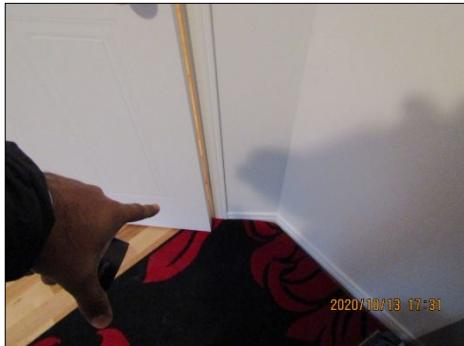
- The inspector observed that the door in the first bedroom did not close properly due to the carpet.
- The Master bedroom door did not latch properly, needs adjustment.
- Overall Usable

Did not close properly

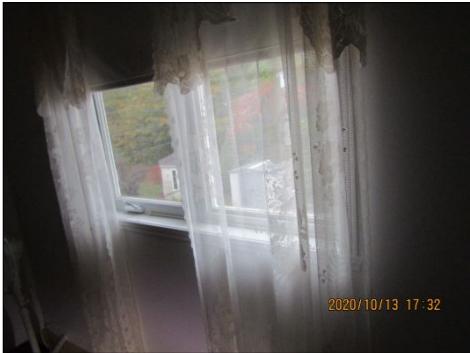
2020/10/13 17:32

- (Broken Seal) Overall acceptable considering the age of the building, however, the windows (thermal pane seals) are towards the end of their life expectancy, and they will require to be replaced in the near future. Failed seals reduce the energy efficiency of the windows. It is recommended to consult with a qualified contractor for further evaluation of proper replacement along with all associated costs.

One example of broken seal (all bedroom windows have the same issue)

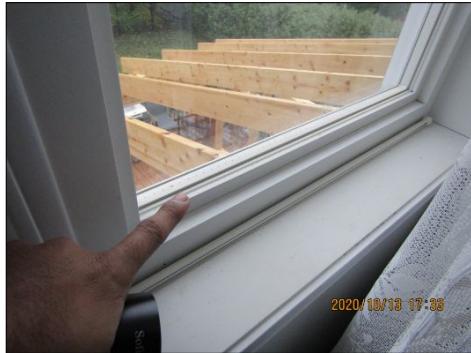
2020/10/13 17:33

Broken seal example

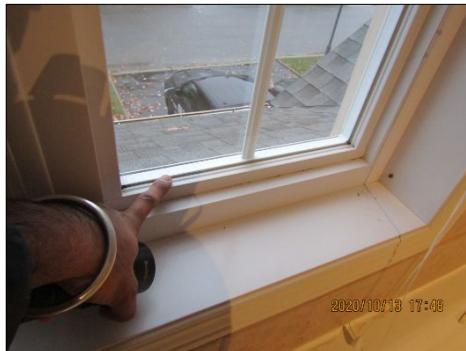
- (Broken Seal) Overall acceptable considering the age of the building, however the windows (thermal pane seals) are towards the end of their life expectancy, and they will require to be replaced in near future. Failed seals reduce the energy efficiency of the windows.

Broken seal

It is recommended to consult with a qualified contractor for further evaluation of proper replacement along with all associated costs.

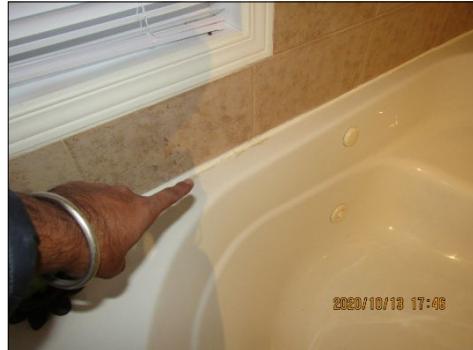
- Caulking old/damaged.
- Application of silicone is recommended on all corners to prevent water infiltration and damages.
(Part of regular maintenance)

Damaged caulking

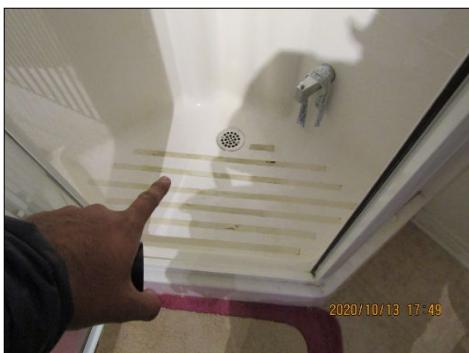
- The shower cabinet was old and yellowish. In the inspector's opinion the base/surround is near the end of its useful life.

Near the end of its life

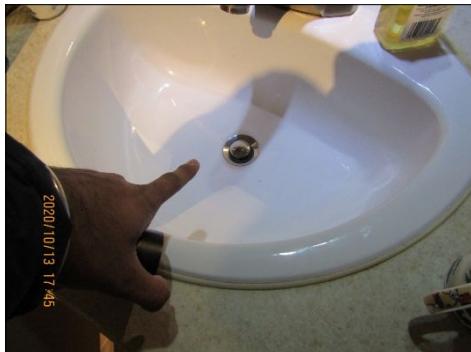
- Inspector observed the sink was draining slowly at the time of the inspection. Cleaning/improvements required.

Slow drainage

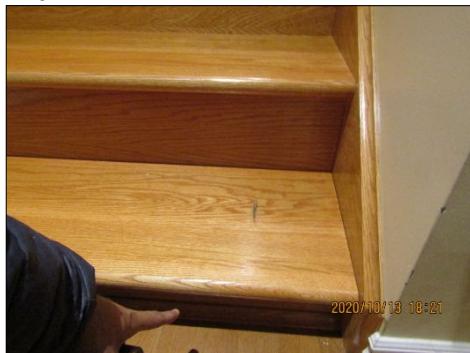
- Uneven steps were noted. This is often caused by the installation of a floating floor. Corrections are recommended to enhance safety.

Uneven lower step

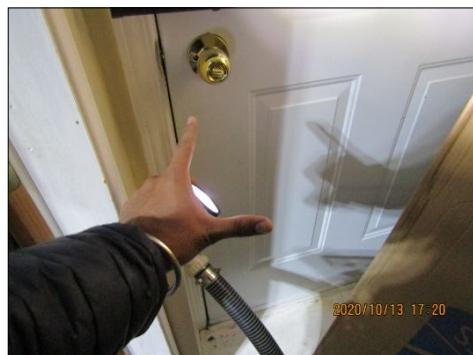
- Unable to operate, blocked by personal property at the time of inspection. Suggest confirming proper operation prior to close.

Storage limitation

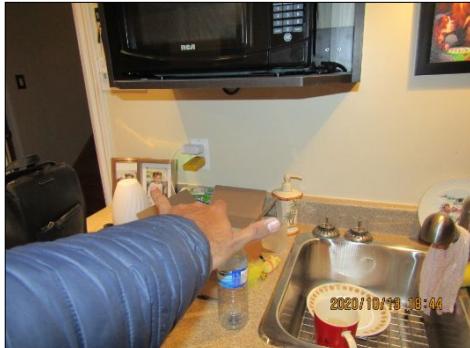
- No GFCI protection present; suggest installing GFCI protected receptacles for safety.
- Presence of a loose outlet noted above the kitchen sink cabinet. This is considered a safety hazard. Corrections required to enhance safety.

No GFCI

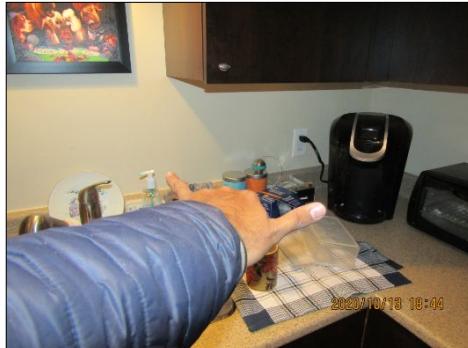
No GFCI

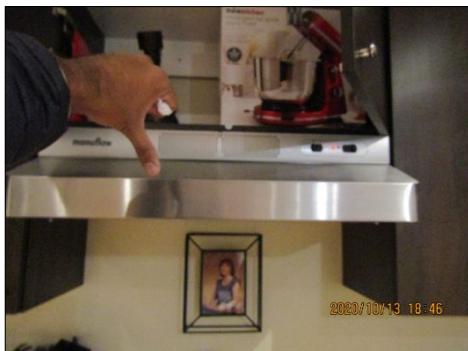
Ventilation: None. Installation recommended with exterior outlet for humidity control.

Not working properly

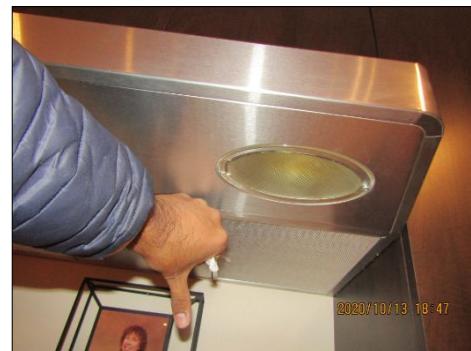
Not working properly

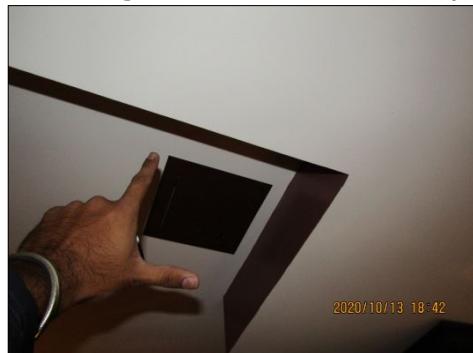
- The panel on the ceiling was screwed tight, could not able to open. (Limitation)

Limitation

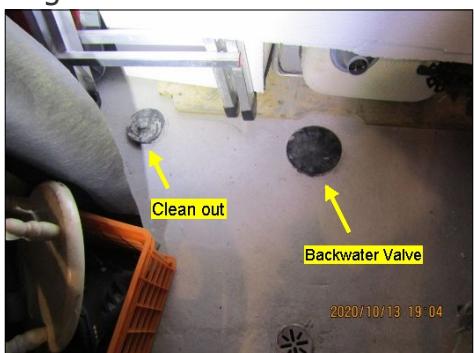
backwater valve and cleanout
were present in the cold room

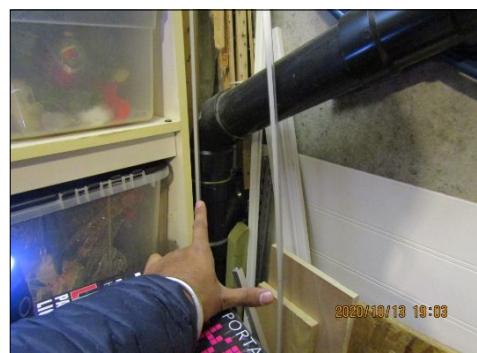
Clean out Not verified
(Limitation)

- One Backflow valve was located in the cold room (visible during inspection).
- One of the clean out appears to be located in the basement (mechanical room), next to the furnace, however it was covered with storage and was not accessible. It is recommended to locate the clean out for emergency cases.
- Two floor drains were located in the basement (1st next to the hot water tank, 2nd in cold room). However, the efficiency of the floor drain is not within the scope of this inspection. Floor drain may dry out over time and letting sewer smell entering the building. Adding water on regular basis is recommended.

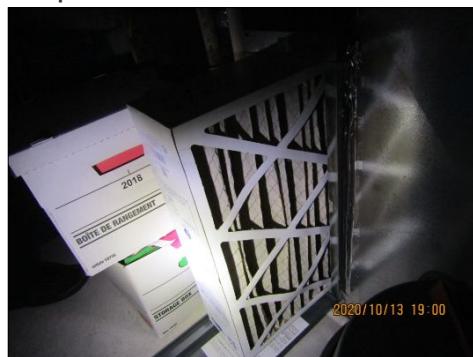
- Acceptable, changing or regular maintenance on the filter on regular basis and according to the manufacture recommendations is required.

Clean at the time of the inspection

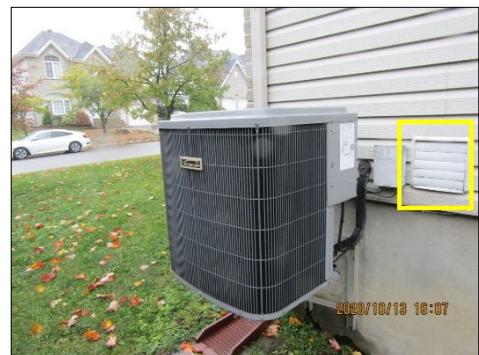
Dryer exhaust vent very close to the AC condenser unit
